Improving the Fort Point Channel A Challenging IDDE Project in Boston, MA

Fort Point Channel CSO 070 IDDE Project
By Kleinfelder in partnership with
Boston Water and Sewer Commission

Jonnas Jacques, P.E.

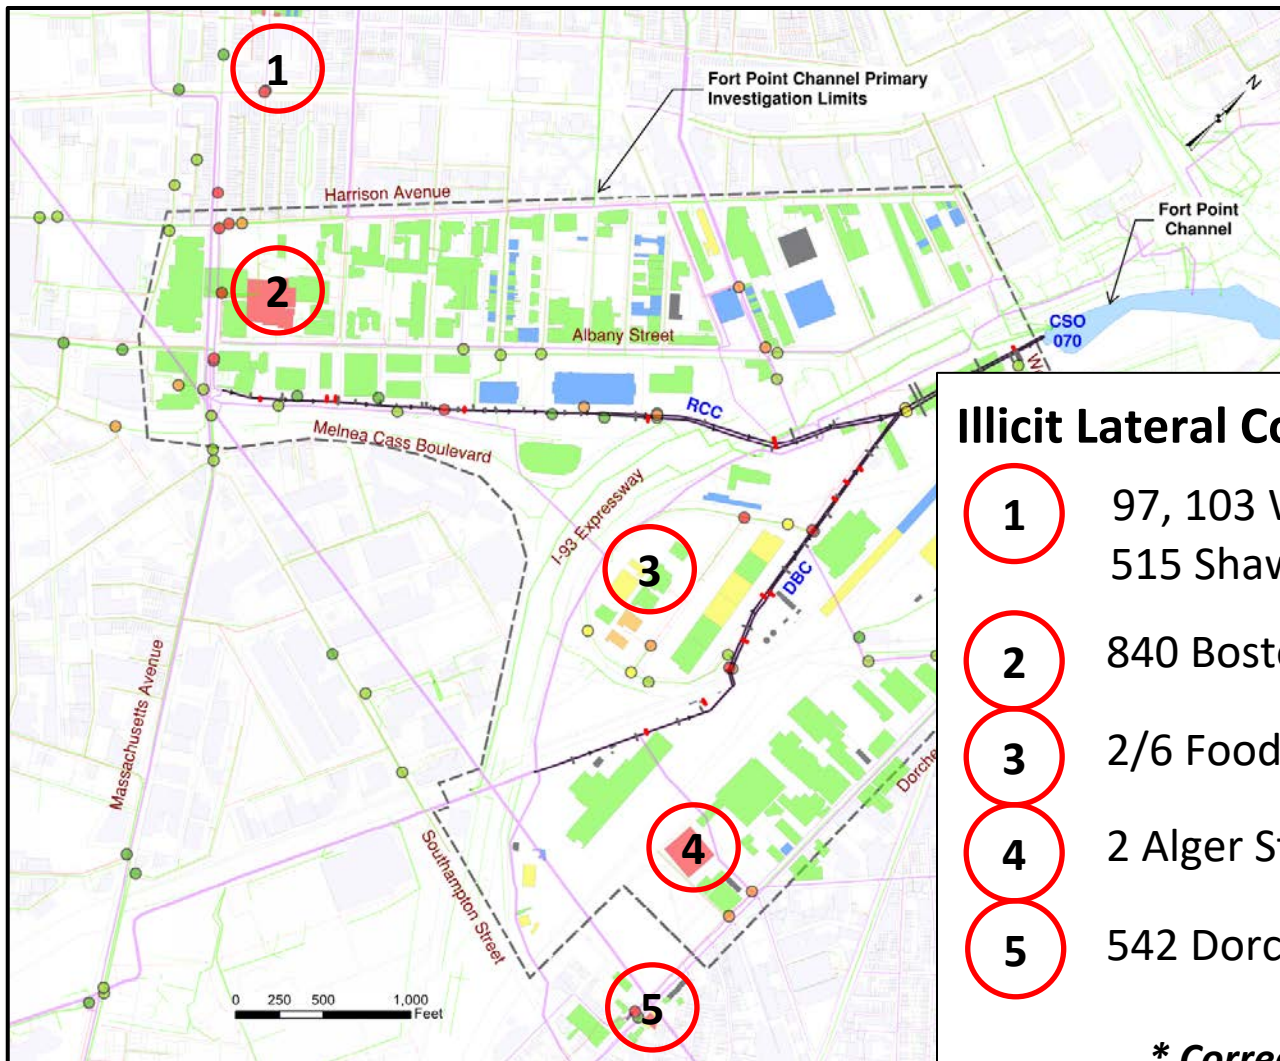
Findings – Building Inspections

Illicit Lateral Connections Identified

- 1 97, 103 West Springfield St & 515 Shawmut Avenue*
- 2 840 Boston Medical Place
- 3 2/6 Foodmart Rd (**corrected**)**
- 4 2 Alger Street (**corrected**)**
- 5 542 Dorchester Avenue

* *Correction pending Spring 2019*

** *10,774 gpd removed from FPC*

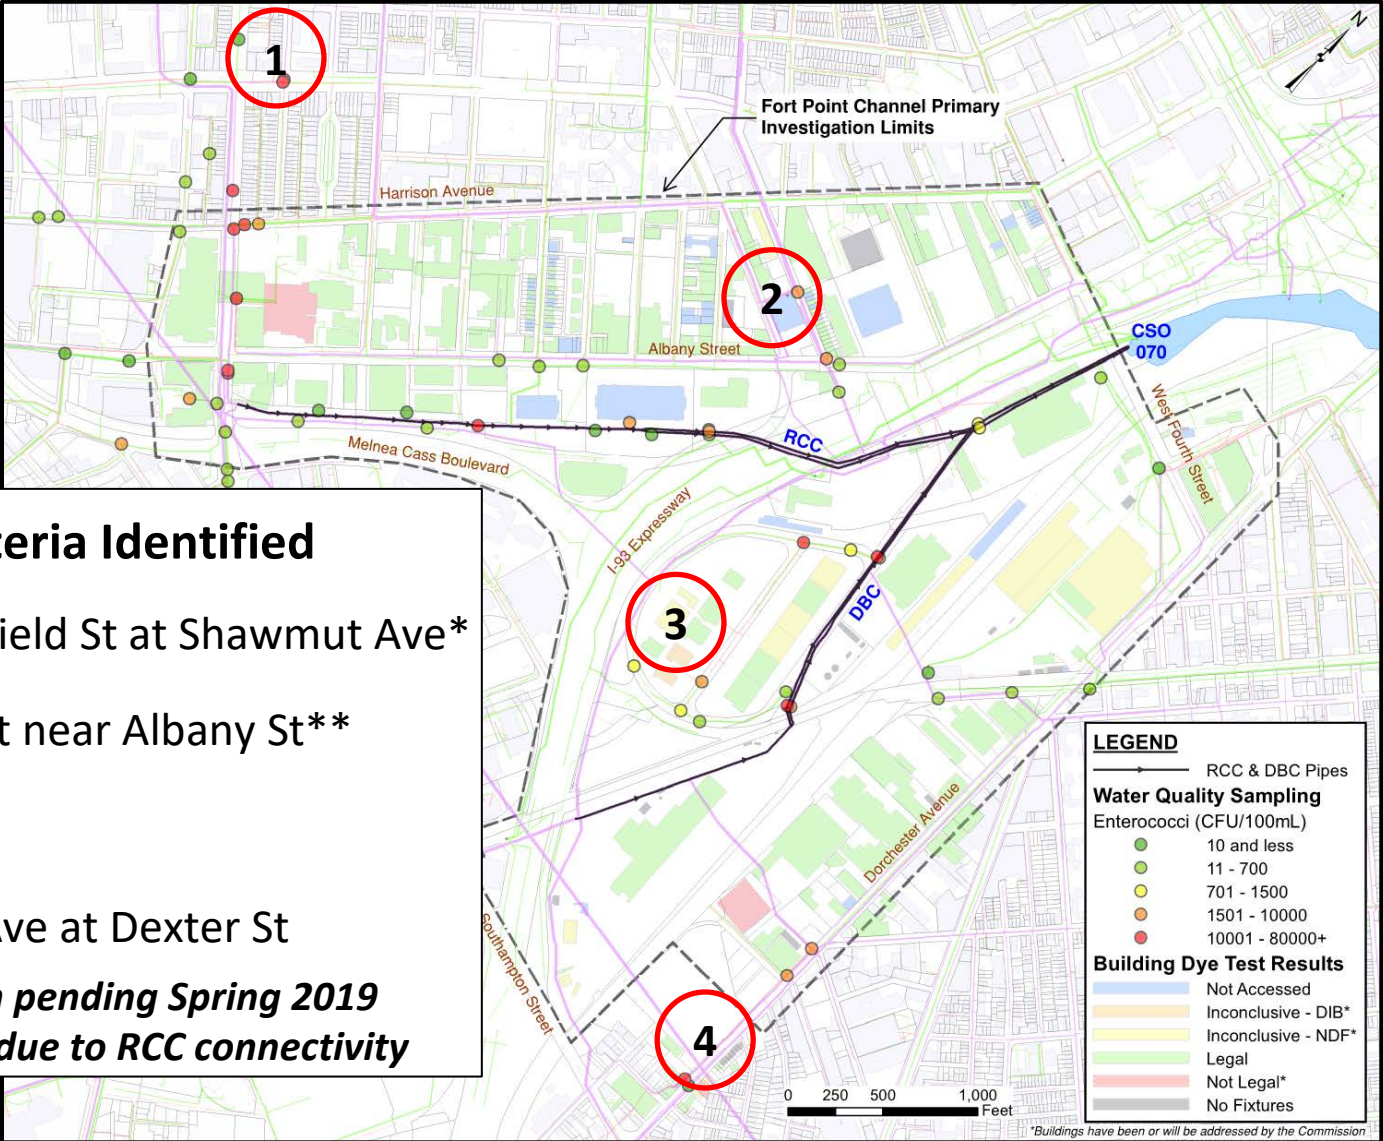
Findings – Water Quality Sampling

Areas of High Bacteria Identified

- 1 West Springfield St at Shawmut Ave*
- 2 Union Park St near Albany St**
- 3 Widett Circle
- 4 Dorchester Ave at Dexter St

* *Correction pending Spring 2019*
 ** *Possibly due to RCC connectivity*

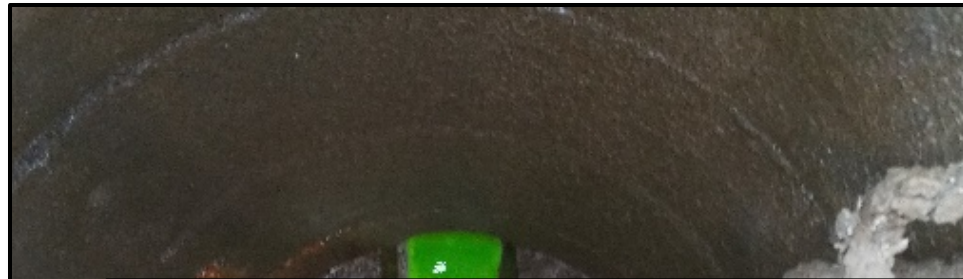
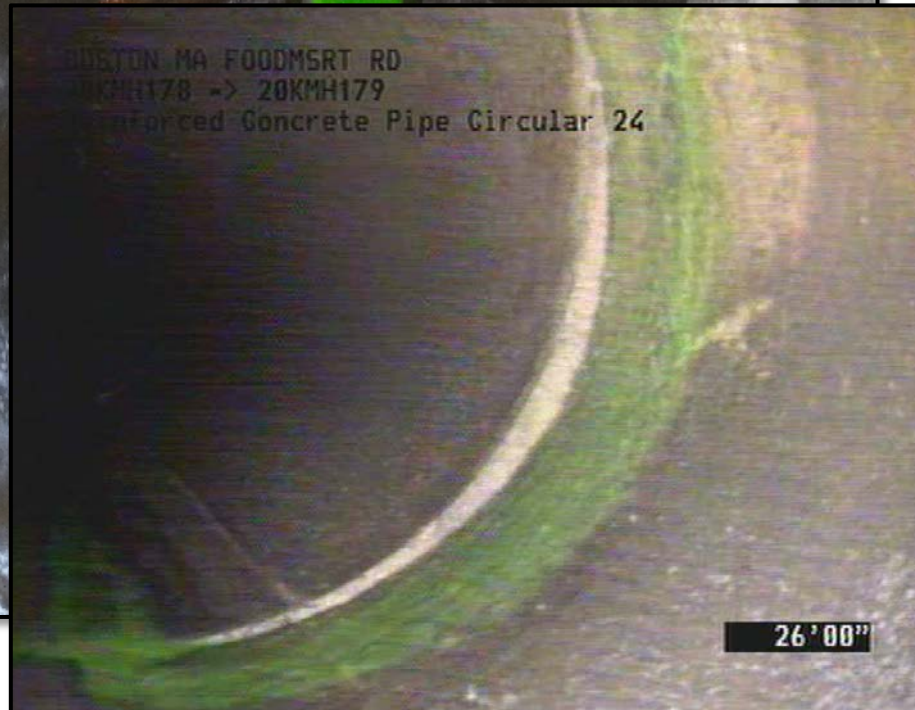
Findings – Dyed Water Tracing

- **West Springfield Street** - Verified direct connectivity of sanitary sewer to RCC
- **West Fourth Street** – Confirmed connectivity to the RE 10-7 regulator
- **2/6 Foodmart Road** – Indirect illicit connection was found using dyed water tracing

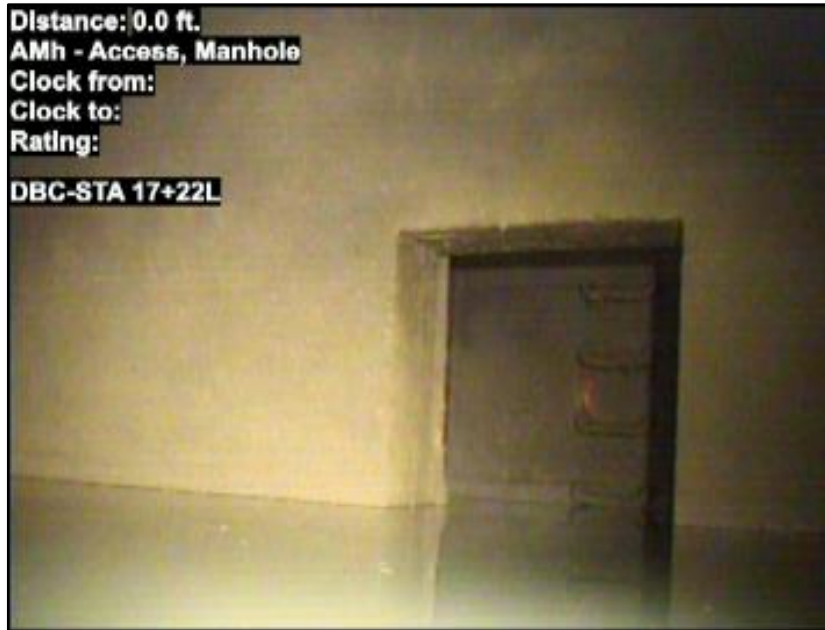
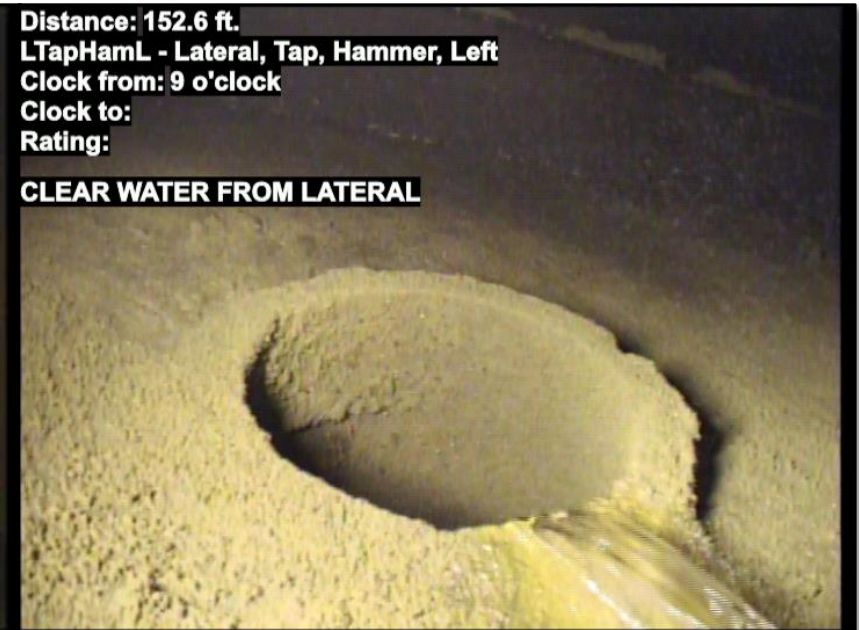
Findings – RCC/DBC Pipe Inspections

- 12,360 feet of conduits inspected
 - RCC/DBC are in good condition
 - 82 RCC/DBC connections identified
 - 60 connections to be added to the BWSC GIS
 - 6 abandoned connections
 - 15 with unknown sources
- Although based on additional field investigations, these 15 are not suspected to be contributors to FPC WQ issues.***
