Improving the Fort Point Channel A Challenging IDDE Project in Boston, MA

Fort Point Channel CSO 070 IDDE Project
By Kleinfelder in partnership with
Boston Water and Sewer Commission

Jonnas Jacques, P.E.

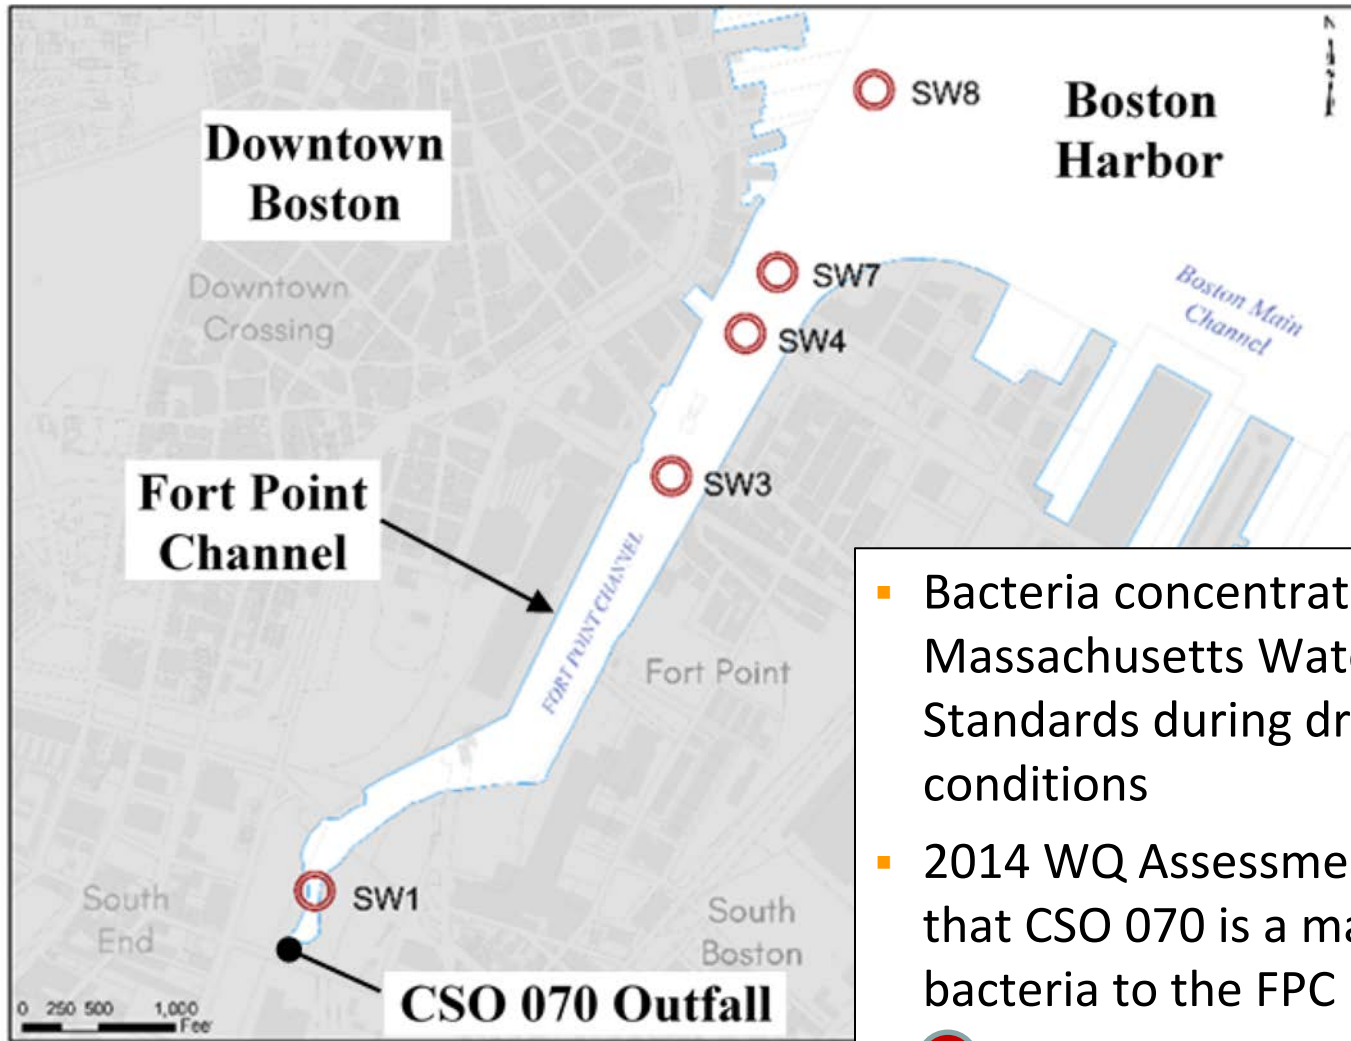
- Bacteria concentration in FPC exceeds Massachusetts Water Quality (WQ) Standards during dry weather conditions
- 2014 WQ Assessment determined that CSO 070 is a major contributor of bacteria to the FPC
-

FPC Pathogen WQ Standard Exceedances During Dry and Wet Weather

- MWRA water quality data indicates improved water quality in the Fort Point Channel
- **What is causing these dry weather exceedances???**

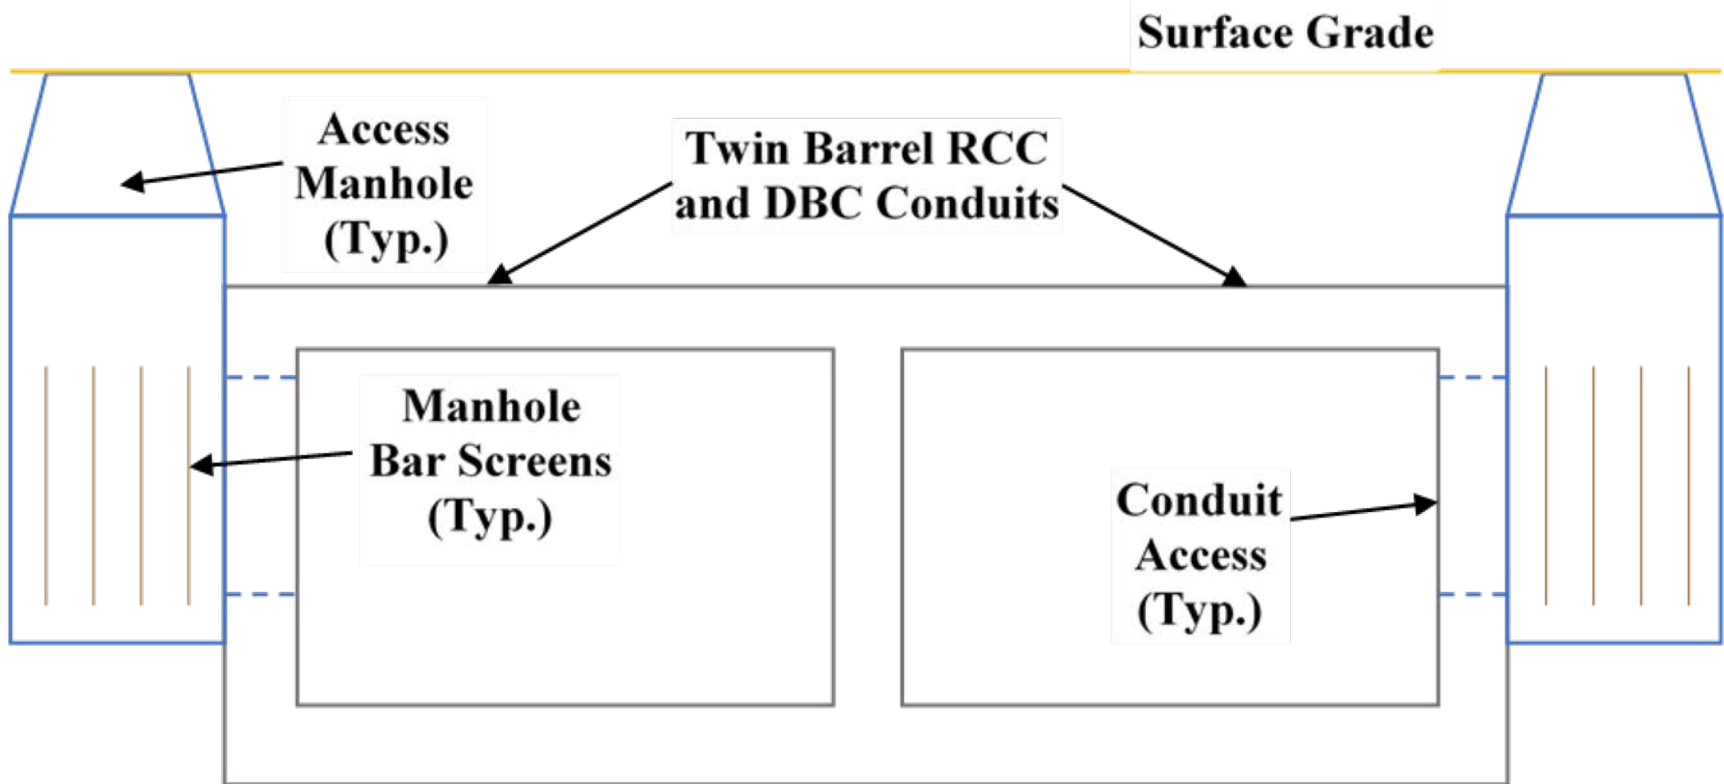
CSO 070 Conduit Configuration

- **Roxbury Canal & Dorchester Brook** Conduits (RCC/DBC)
- 2 miles of reinforced concrete culverts built in the 1960s
- Stormwater outfall with CSO activity

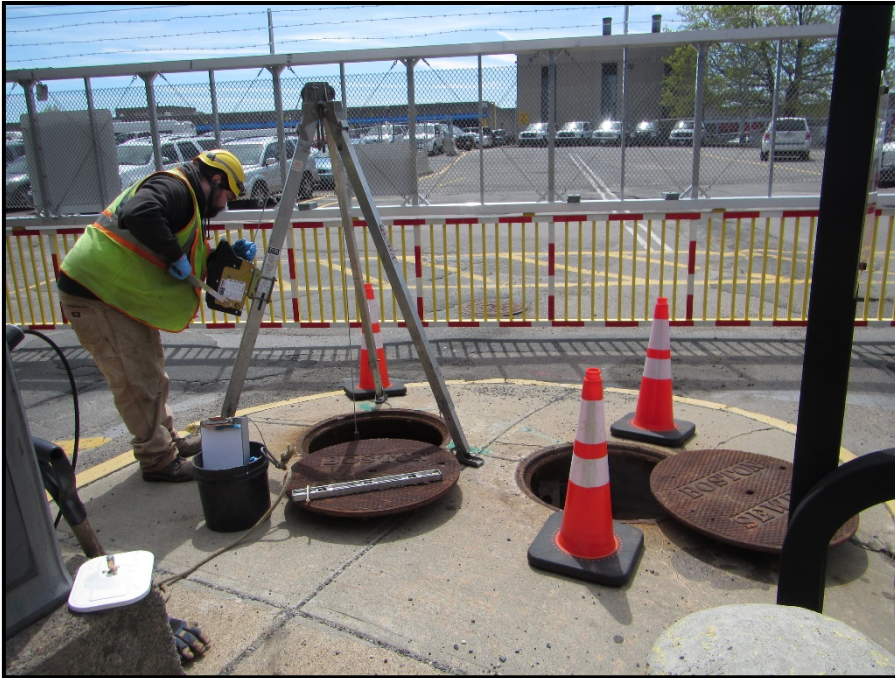
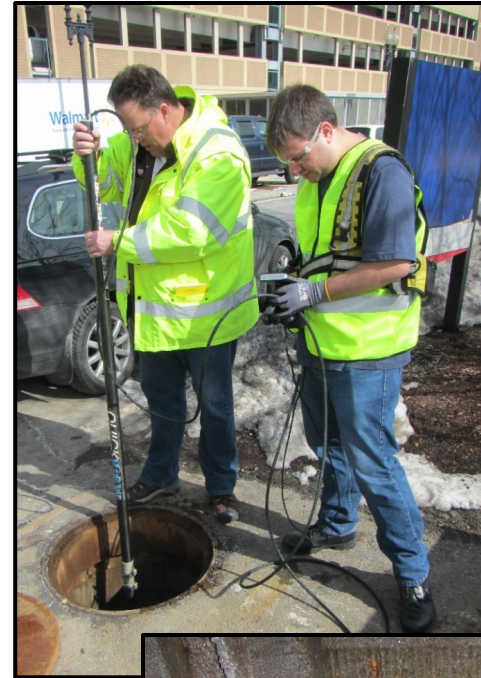
Field Inspections

- Confined-space entry inspection of regulators and RCC/DBC conduits
- Pole-camera inspection of manholes to verify connectivity

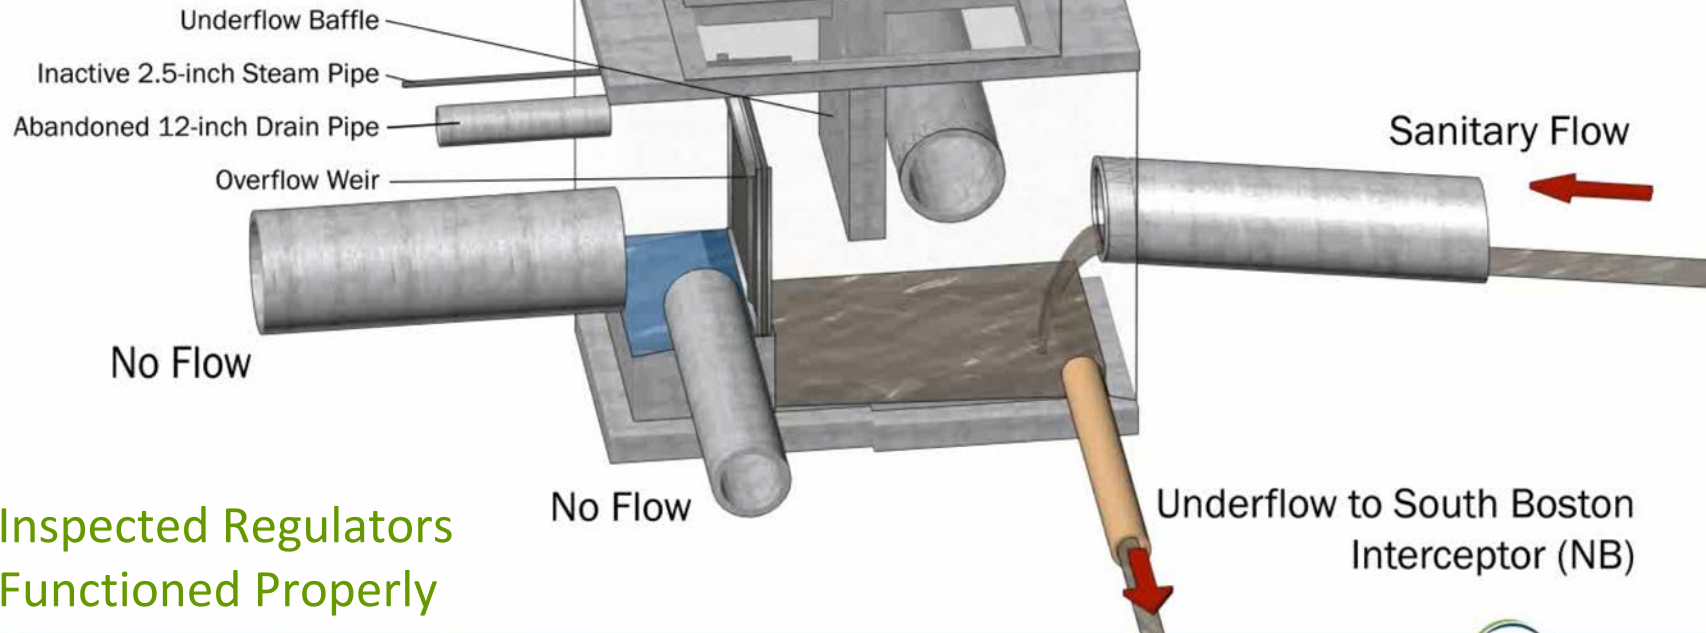
Regulator
21KRE07010-7

Little or no Flow

Inspected Regulators
Functioned Properly

Normal Dry Weather Conditions
